# Geological hazards at the main dam of Dap Troi reservoir, Ninh Binh Province, Vietnam

Ban To Xuan<sup>1\*</sup>

<sup>1</sup>Hanoi University of Mining and Geology

## ABSTRACT

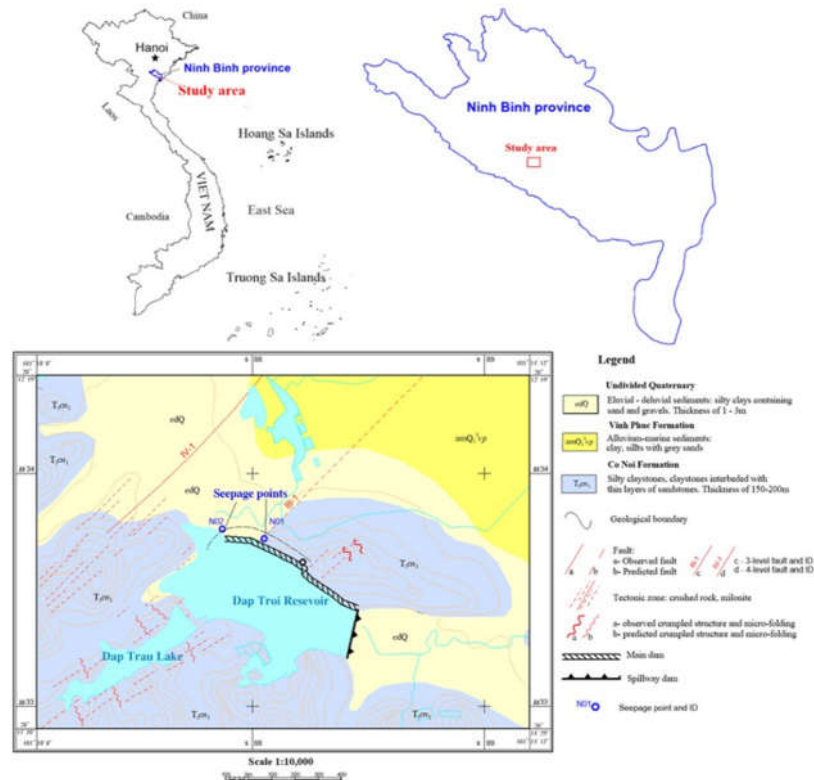
Two major seepage zones have been identified. At location N-01, water flows continuously in a stream, eventually draining through a concrete ditch into nearby rice fields, with an estimated flow rate of several tens of cubic meters per hour. At location N-02, seepage appears as slow filtration rather than flowing water, but remains active (Figure 1).

Figure 1. Sketch geological map of the Dap Troi Lake showing the locations of water leaking points

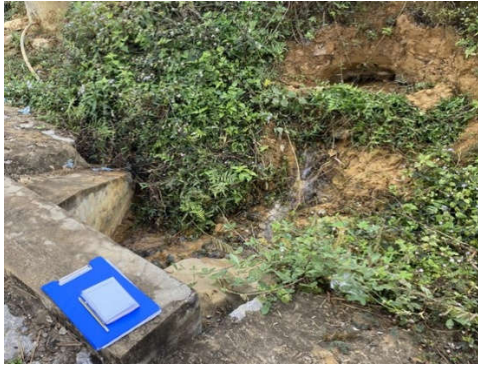
Since 2020, seepage has been observed at the dam's downstream toe, as confirmed by field surveys and reported in media sources. Visible leakage flows from the dam body are evident (Figure 2 and 3). According to local sources, this seepage has significantly affected the livelihoods of residents. During the rainy season, persistent waterlogging disrupts rice cultivation, while in the dry season, water shortages are reported. Furthermore, one of the major leakage points lies adjacent to an inter-village road, impeding local transportation and raising safety concerns.

*Figure 2. Seepage point with visible flow at the toe of the Dap Troi Reservoir dam (surveyed on 03/12/2021)*

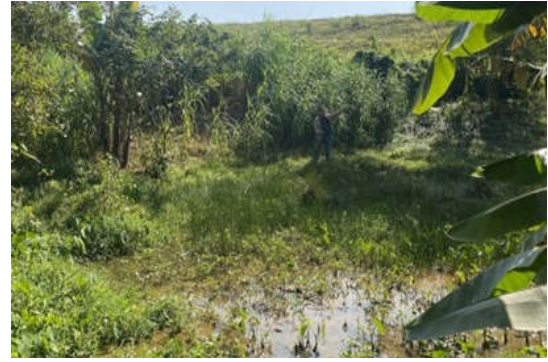
*Figure 3. A seepage point at a residential house (on 03/12/2021)*

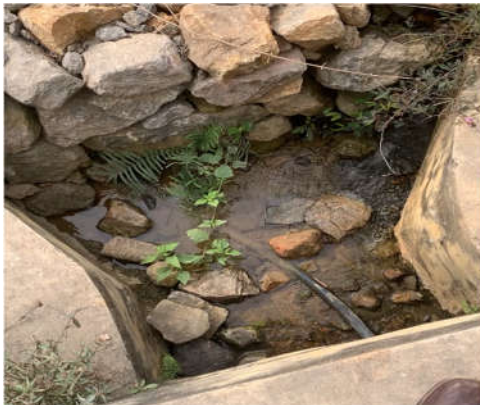
*Figure 4. First seepage point at the downstream toe of Dap Troi Dam (26/12/2022); seepage persisted after slope stabilization and grouting*

To mitigate seepage hazards through the foundation, it is recommended to implement deep pressure grouting. The grouting Wells should fully penetrate the apQ layer as well as the karst cavities within the IB zone. Based on available data, the required depth of the grouting Wells, measured from the dam crest, is estimated to range from 25 to 35 meters on average.

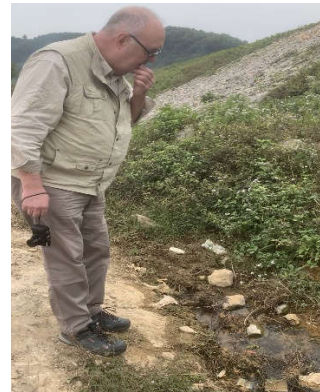
*Figure 5. Field survey at a seepage point located 15 m upstream of leakage point at the downstream toe of Dap Troi Dam (18/01/2023), when the reservoir water level was low*

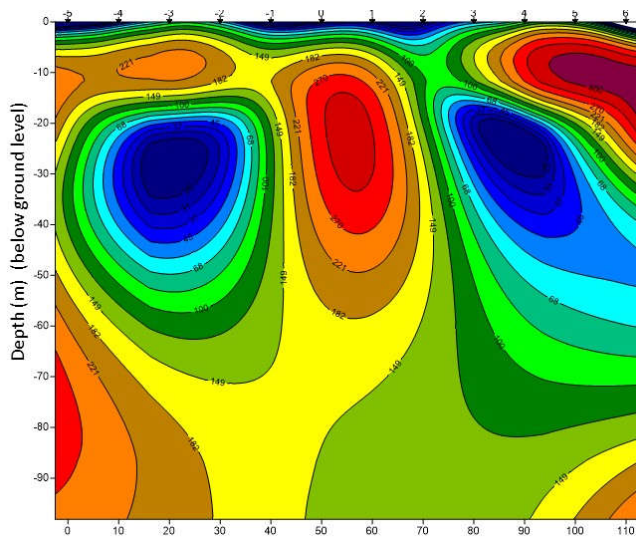
Figure 6 and 7 show profiles of electrical resistivity sounding at the measured line DT2-2 and DT2-3 respectively. Interpretation of geophysical profiles of reveal fault zones intersecting the dam alignment along survey lines DT2-1, DT2-2, and DT2-3. These tectonic faults are deep-seated, extending to depths of approximately 60–70 m, and trend predominantly NE–SW to sub-meridional.

Figure 6. Electrical resistivity section along DT2-2 (blue zones indicate low-resistivity, water-bearing pathways).

Geophysical interpretation (ERT and GPR) reveals the presence of deep-seated fault zones intersecting the dam alignment (DT2-1 → DT2-2 → DT2-3), extending to depths of

approximately 60–70 m. These faults, trending NE–SW to sub-meridional, likely serve as preferential pathways for groundwater flow, contributing to sustained seepage beneath the dam.

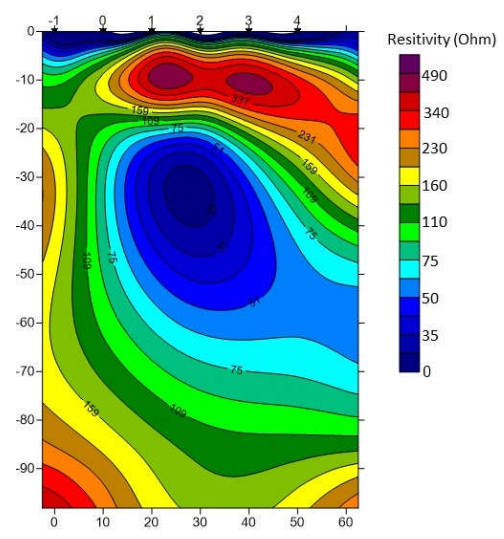
Figure 7. Electrical resistivity section along survey line DT2-3

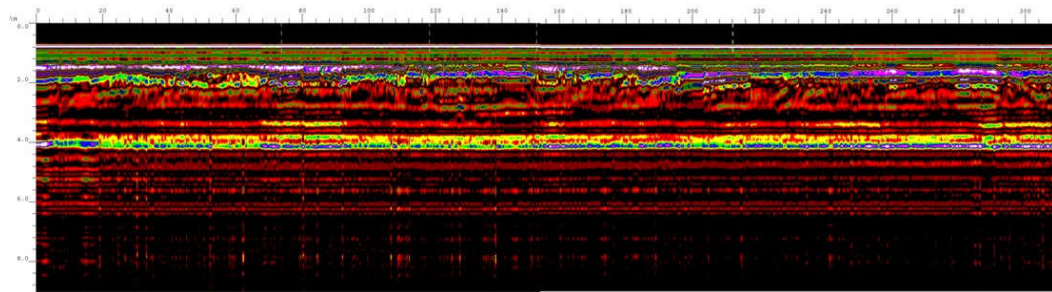
The GPR results do not clearly indicate signs of seepage or cracking within the crest and toe areas of the dam in the investigated zone. However, localized anomalies can be observed at depths of approximately 3.5 m beneath the dam crest (Figure 8) and 4.0 m at the dam toe (Figure 9).

Figure 8. GPR results along the crest of the main dam at Dap Troi Reservoir (in the image, upward-convex features - reversed parabolic reflections - indicate anomalies occurring at depths of approximately 0–3.5 m

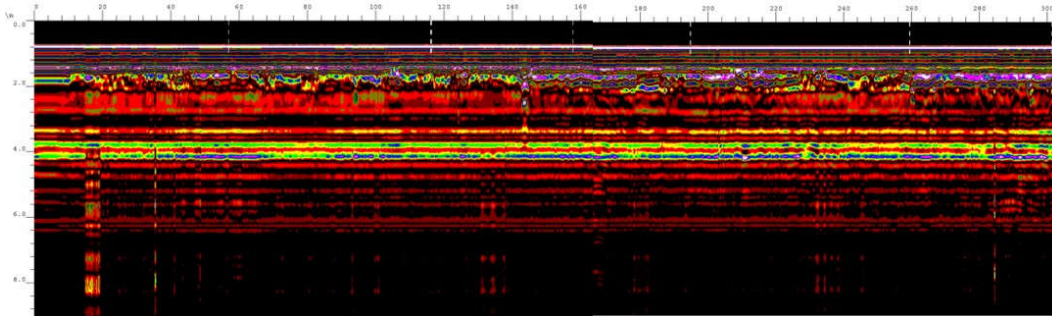
Figure 9. GPR results beneath the concrete road at the downstream toe of the main dam at Dap Troi Reservoir (in the image, upward-convex features—reversed parabolic reflections—indicate anomalies occurring at depths of approximately 0–4 m

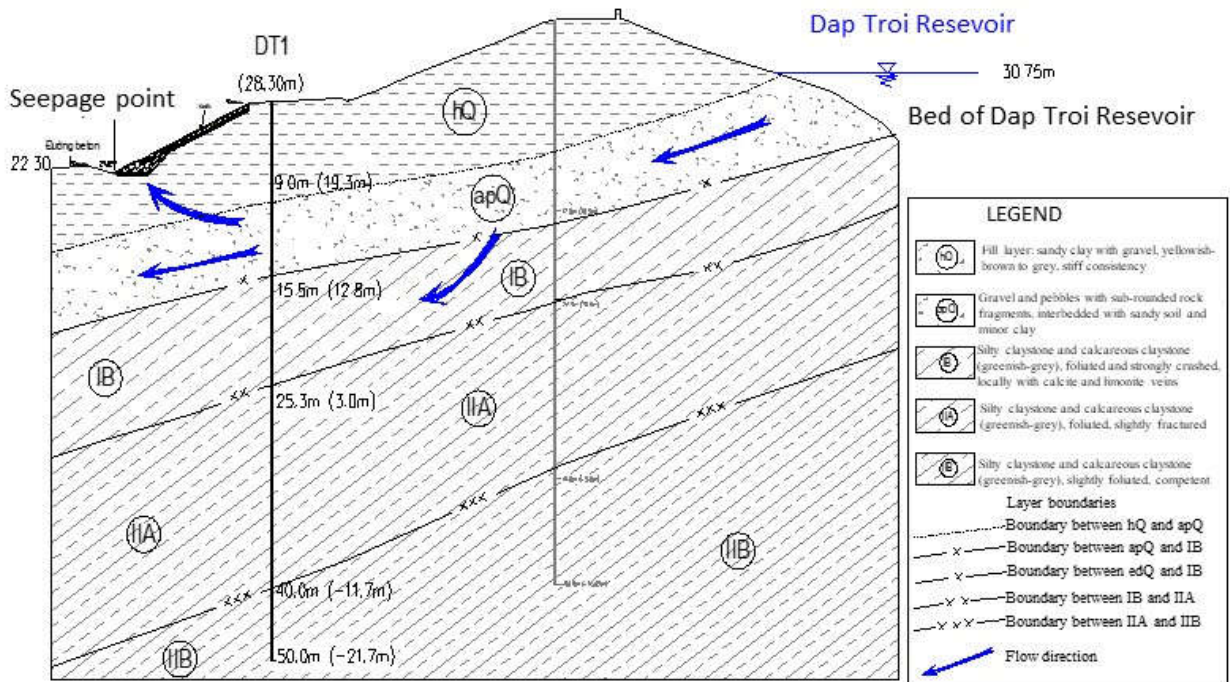
Figure 11. Illustrates the engineering geological cross-section of the dyke body section between Wells DT1 and DT1-I, showing the alluvial and floodplain deposits (apQ layer). Figure 11 presents the engineering geological cross-section from the dam crest through the dam body at Well DT1 to the dam toe, simulating the seepage process from the Dap Troi reservoir bottom through the hydrogeological window (apQ layer) and karst-fractured zones.

Figure 11. Engineering geological cross-section from the crest of Dap Troi Dam through its body (DT1) to the dam toe, illustrating seepage flow beneath the dam through the apQ layer

When the reservoir is impounded, under high pressure, water from the reservoir flows through the voids in the apQ layer, karst cavities, and fractured zones in the IB layer toward the downstream area and toe of the dam. A conceptual model of the seepage flow is shown in Figure 11.

**Objective causes:** The main dam axis is located within a major fault zone, where the bedrock is intensely fractured to depths of 40–50 meters. Along this fault zone, an ancient riverbed was eroded and subsequently filled with thick alluvial and floodplain deposits (apQ) composed of cobbles and boulders, with thicknesses exceeding 10 meters
