# Geological hazards at the main dam of Dap Troi reservoir, Ninh Binh Province, Vietnam

Ban To Xuan<sup>1\*</sup>

<sup>1</sup>Hanoi University of Mining and Geology

## ABSTRACT

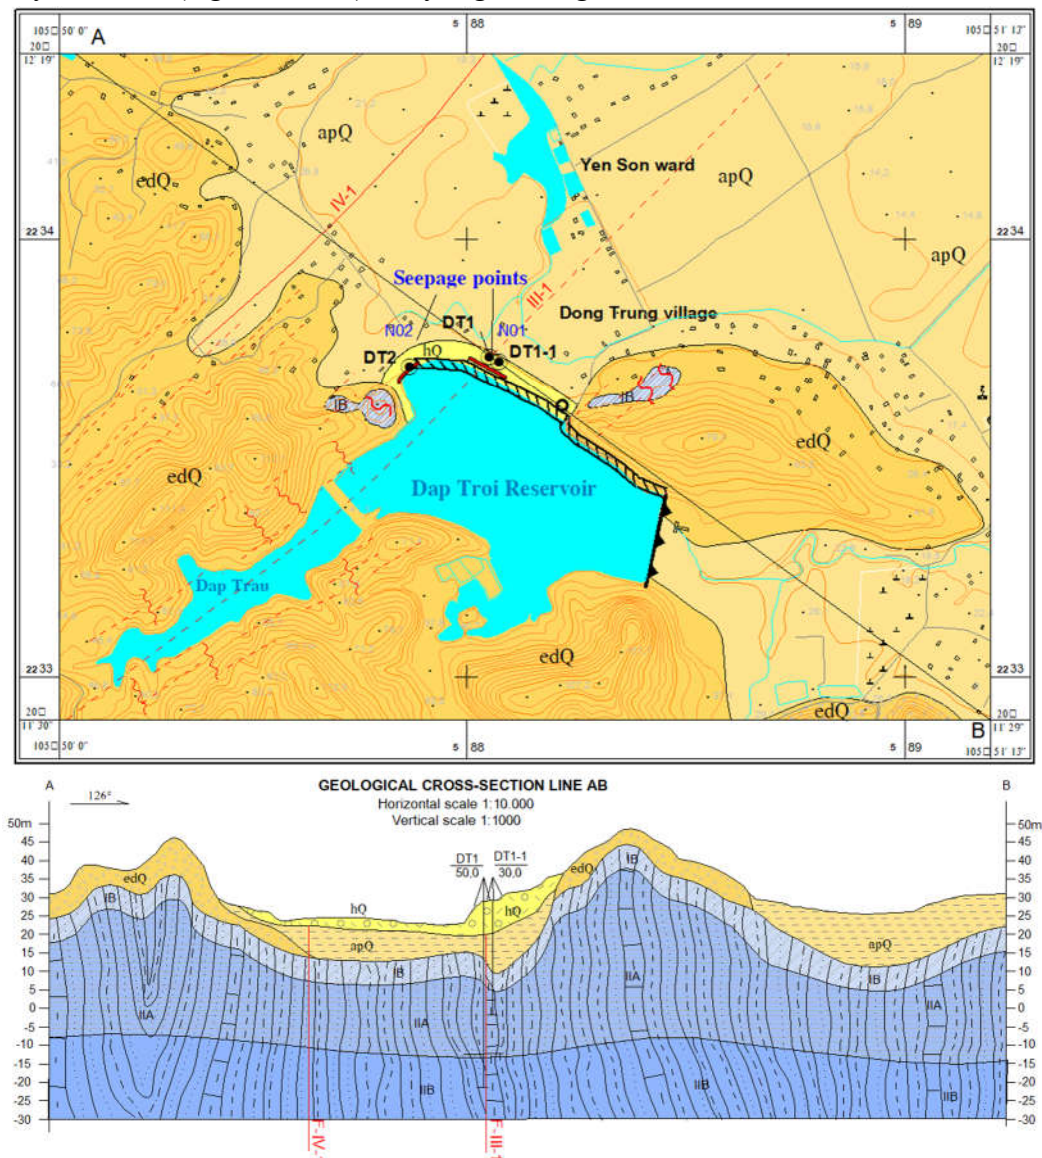
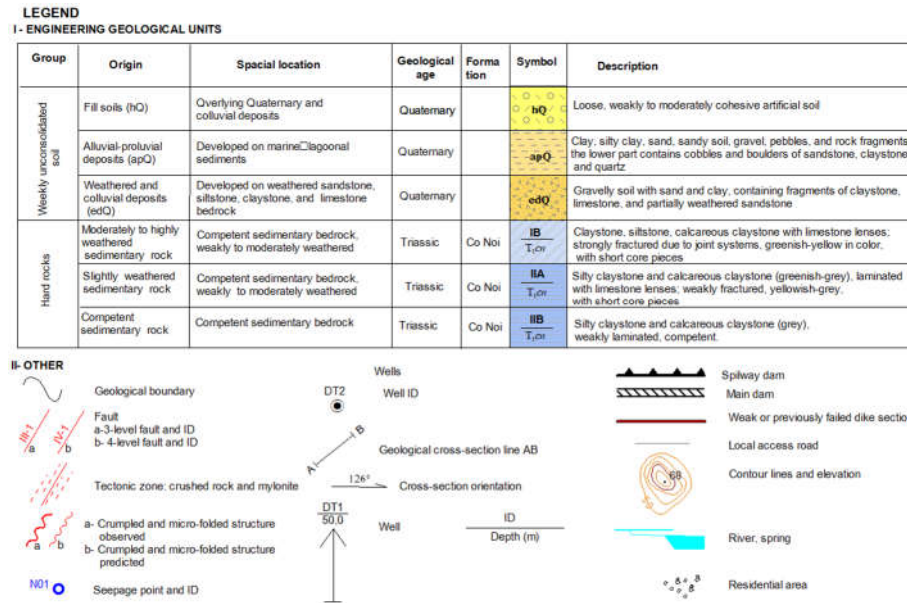
Figure 10. Sketch geoengineering map of Dap Troi Lake and surrounding areas

Figure 10 shows the map and cross-section of engineering geology of the studied area. According to engineering geological classification, the weathering profile developed on the Co Noi Formations is divided into the following zones: Colluvial–residual zone (edQ): Clayey soil with rock fragments; thickness 1–7 m; widely distributed; consistency from plastic to loose; Moderately weathered zone (IB): Fractured bedrock with limonite infill along joints; brownish alteration along fractures; moderate strength; Slightly weathered zone (IIA): Weakly weathered rock with moderate fracturing; joints filled with hydrothermal minerals; high strength; and Relatively intact zone (IIB): Fresh, massive rock with minor fracturing; long core recovery; no secondary minerals (e.g., limonite); very high strength.
